# Stability and Collapse, Old Man of the Mountains, Franconia Notch, New Hampshire

BRIAN K. FOWLER

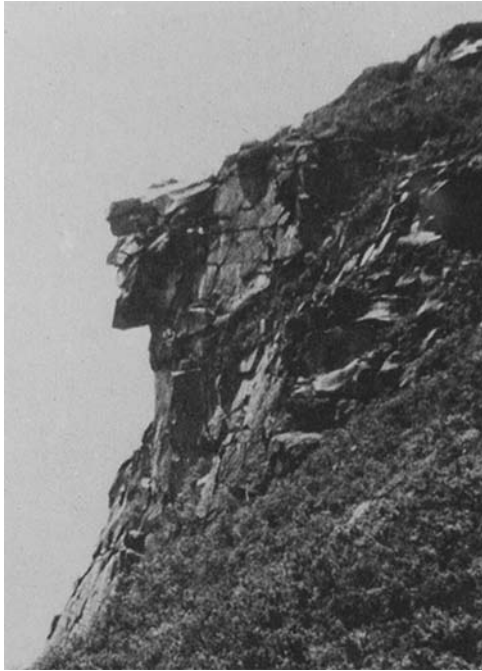
Figure 1. Old Man of the Mountains from Profile Lake, Franconia Notch. Viewpoint about 600 m (2,000 ft) north and 550 m (1,800 ft) below (photo by author, 1976).

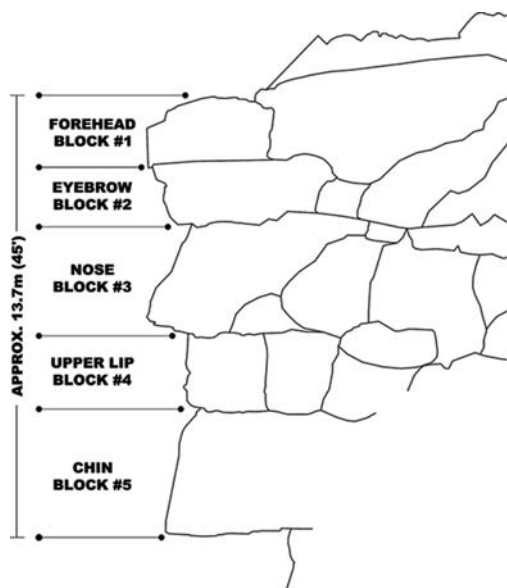
Figure 2. Diagram of Profile's component block combinations.

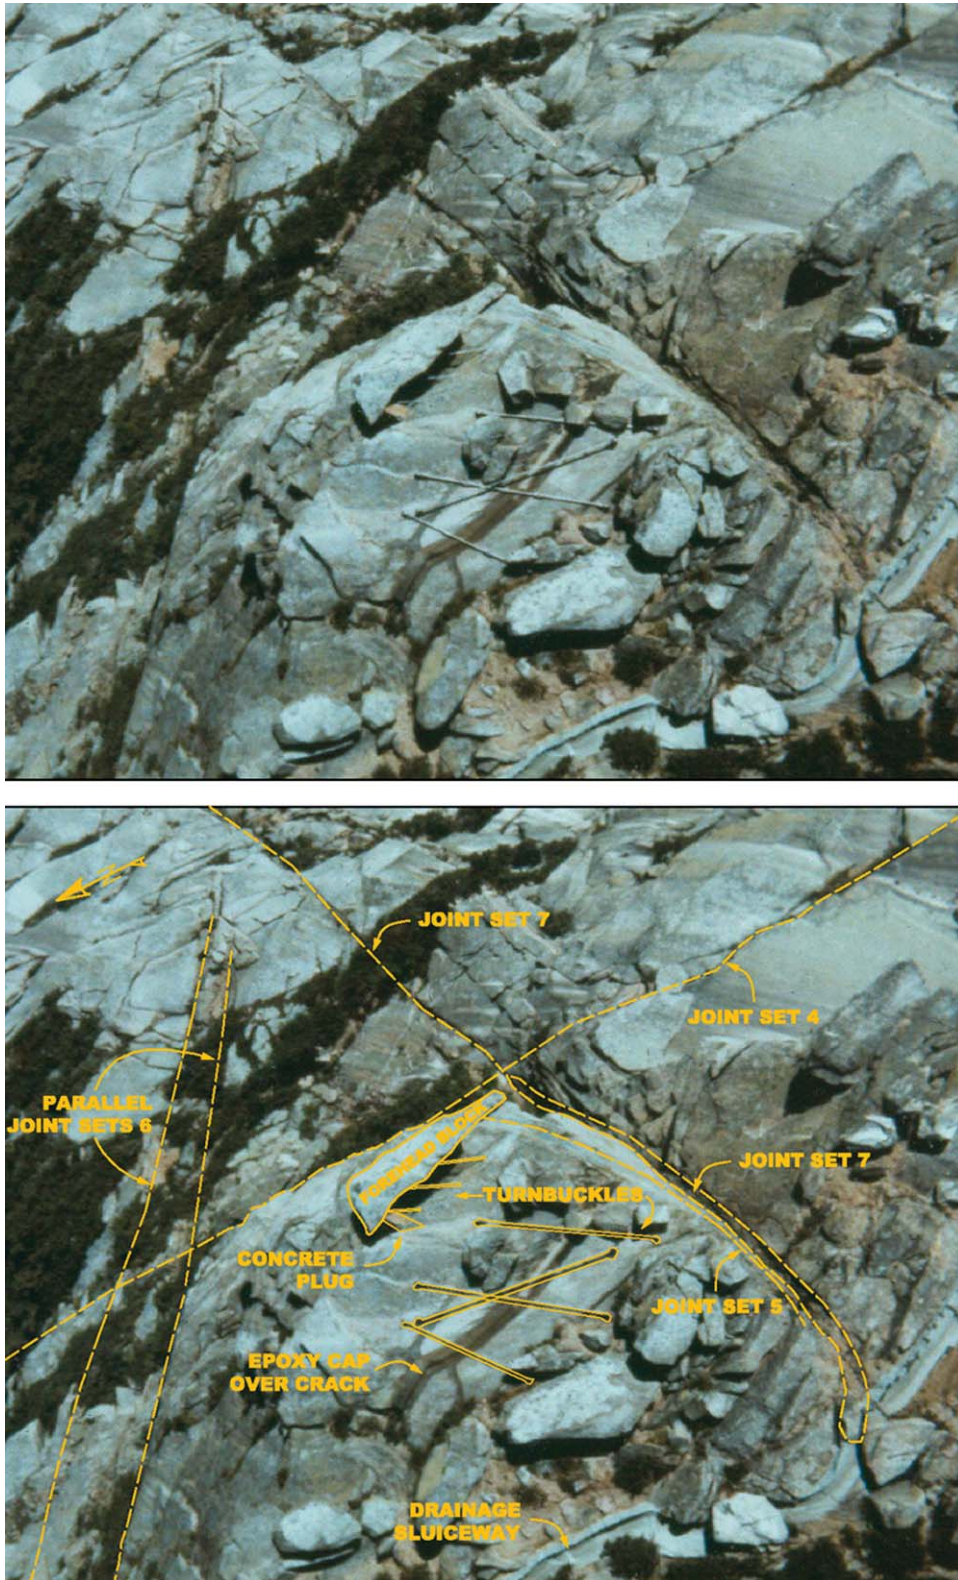
the rock mass of the cliff. Shearing movement within Set 7 appears to have been a combination of linear and twisting displacements that resulted in a net rotation that, as can be seen in Figures 3 and 5, changed the orientation of the sub-vertical face-making joints north and south of the Profile from N20E to N35E (Sets 2 and 3).

Figure 3. Profile's rock mass from about 30 m (100 ft) overhead (top) and overlay view showing important structural geologic and man-made features (photos by D. Hamilton, 1976).

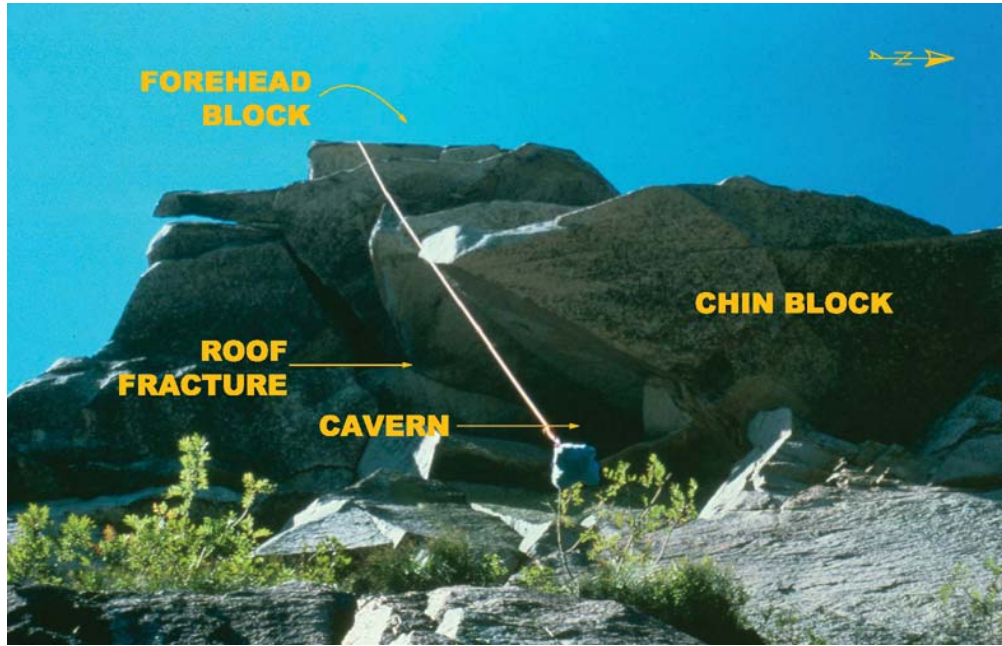
Figure 4. Profile's rock mass from about 25 m (82 ft) directly beneath (photo by author, 1976). Note location of the cavern and the fracture in its roof that separates the roughly triangular-shaped and delicately cantilevered chin and upper lip blocks from the rest of the rock mass.

of their comparatively broad flat blocks was greater than that of the more blocky, triangular, and extensively overhanging Blocks 4 and 5 below. These two blocks instead were cut off from the rest of the rock mass by the cavern and fracture extension behind them (Figures 4, 6, and 7) and thus appeared close to toppling collapse. If this were to occur, given their direct involvement with the likely foundation (point of bearing) of the composite rock mass, the subsequent toppling of Blocks 1–3 would quickly follow once their combined weight was unsupported from below.

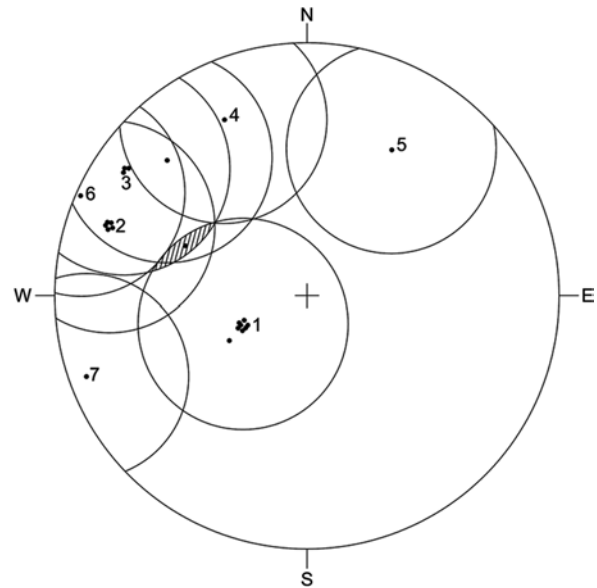
Figure 5. Pole diagram of structural features (lower hemisphere). Set 1, sub-horizontal joints through Profile's blocks. Sets 2–7: sub-vertical joints defining the cliff face south of the Profile (2), the cliff face north of the Profile (3), the cut-off joint east of Blocks 2–5 (4), the south face of the Profile (5), the north face of the Profile (6), and the shear zone south of the Profile's rock mass (7).

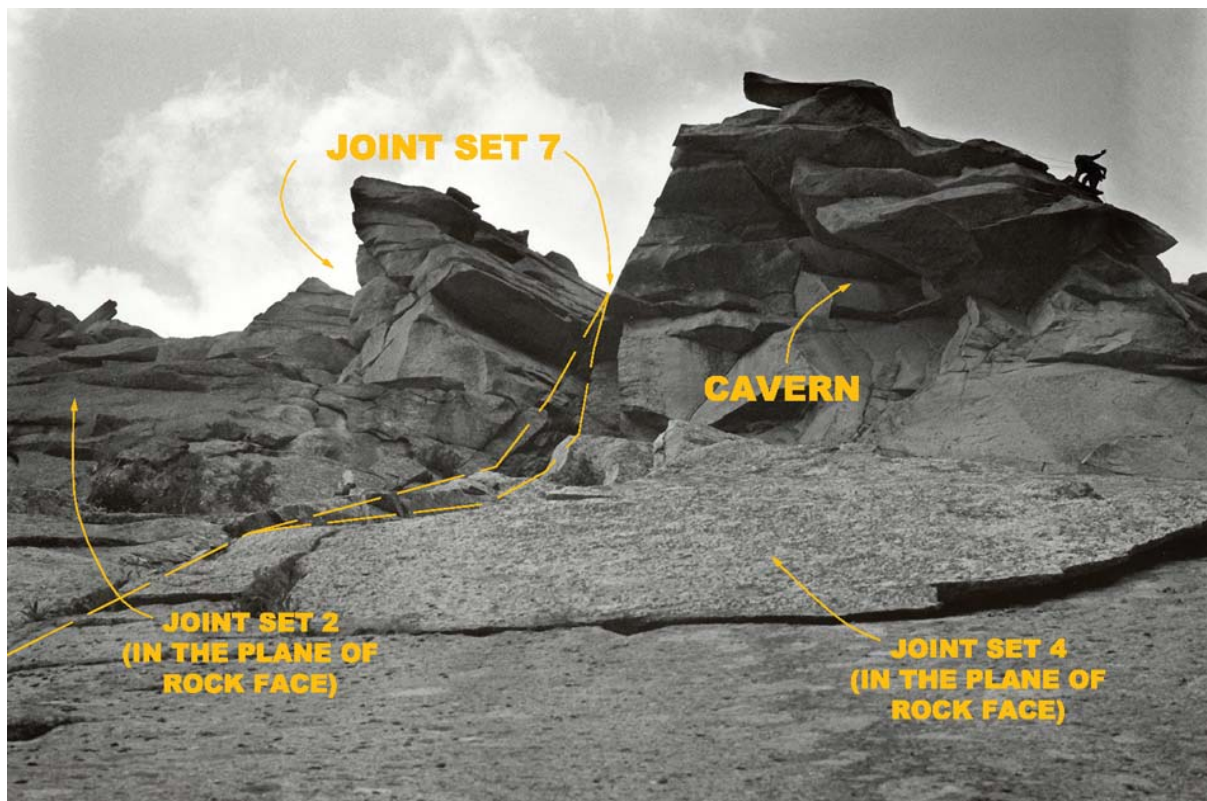
The significance of Set 7 in the formation of the Profile was most interesting (Figures 3 and 5). The faulted shear zone at the junction of the south face of the Profile and the cliff face and a similarly oriented zone about 15 m (50 ft) to the south (Figure 6) are major structural features in

Figure 6. Profile's rock mass on the right (north) and adjacent rock mass on the left (south) showing location and influence of the two parallel Set 7 structures on block breakage patterns on the cliff (photo by S. Young, 1958).

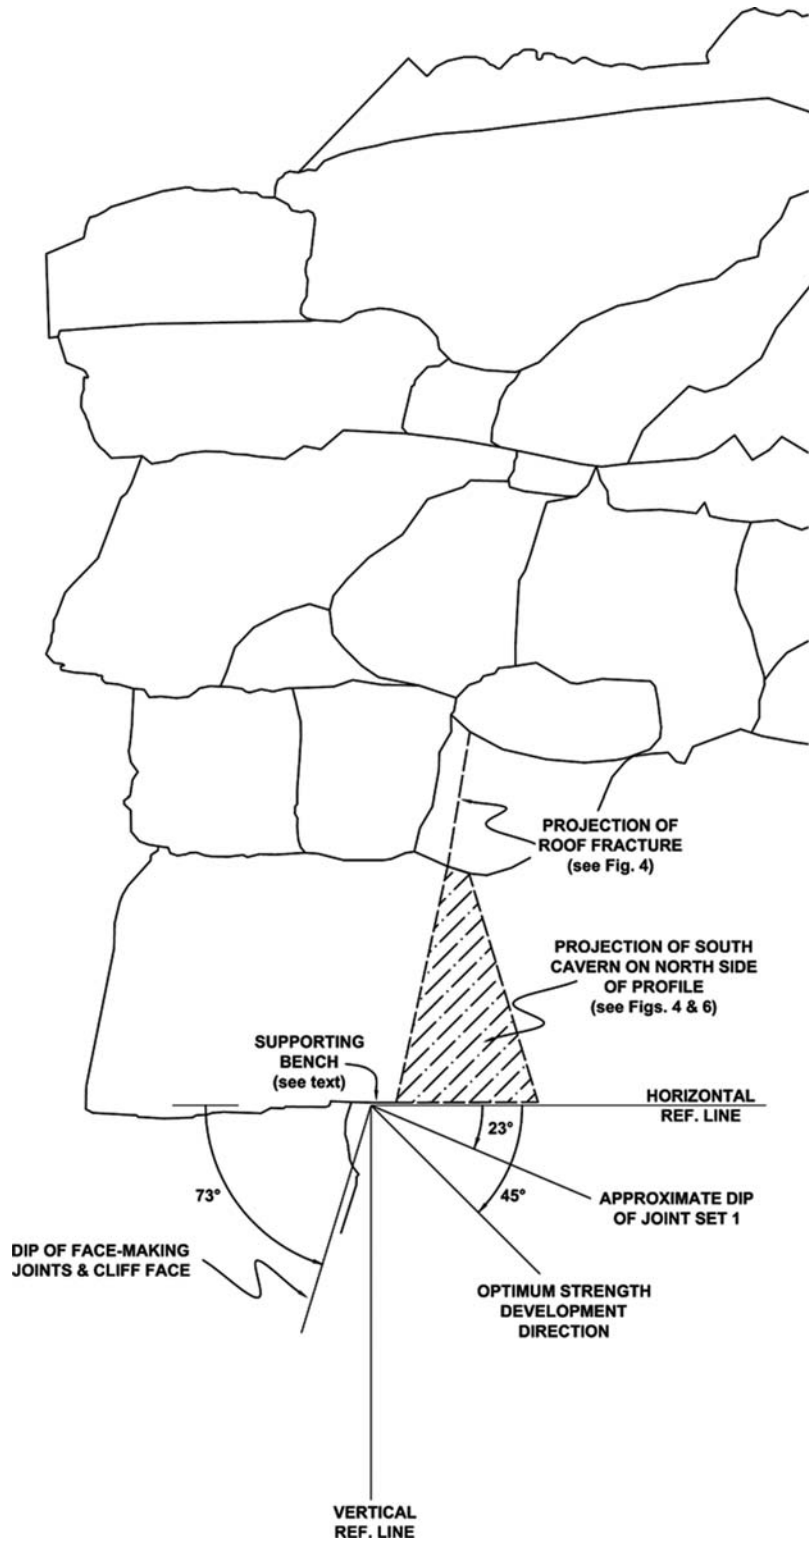
of bearing likely located beneath the supported portion of the chin, as illustrated in Figure 7. Thus, the Profile's composite rock mass was precariously cantilevered in position by its own dead weight. The security of this mechanism was, however, clearly delicate because of the very precariously cantilevered configuration of Blocks 4

First, based on the dimensional and spatial data and the rudimentary mechanical analysis, the cantilevering mechanism of the Profile's in-place stability was postulated as illustrated in Figure 7.

Figure 7. Estimated structural-mechanical relationships immediately beneath the chin.

The mechanism and sequence of the collapse can be reliably conceptualized by referring back to Figure 7, a sketch of the Profile's pre-collapse rock mass viewed from the north. Based on all that was known of its pre-collapse structure and the particular stability of its various parts, it appears the collapse likely occurred in two nearly simultaneous stages.

strength of the granite in the narrow bench and gradually weakened it sufficiently so it could no longer remain intact. When this foundation suddenly disintegrated, the chin was no longer supported and toppled forward and downward, taking the upper lip and the rest of the rock mass above with it as the blocks broke off along the joints bounding them to the rear (Figure 7, fracture extension).

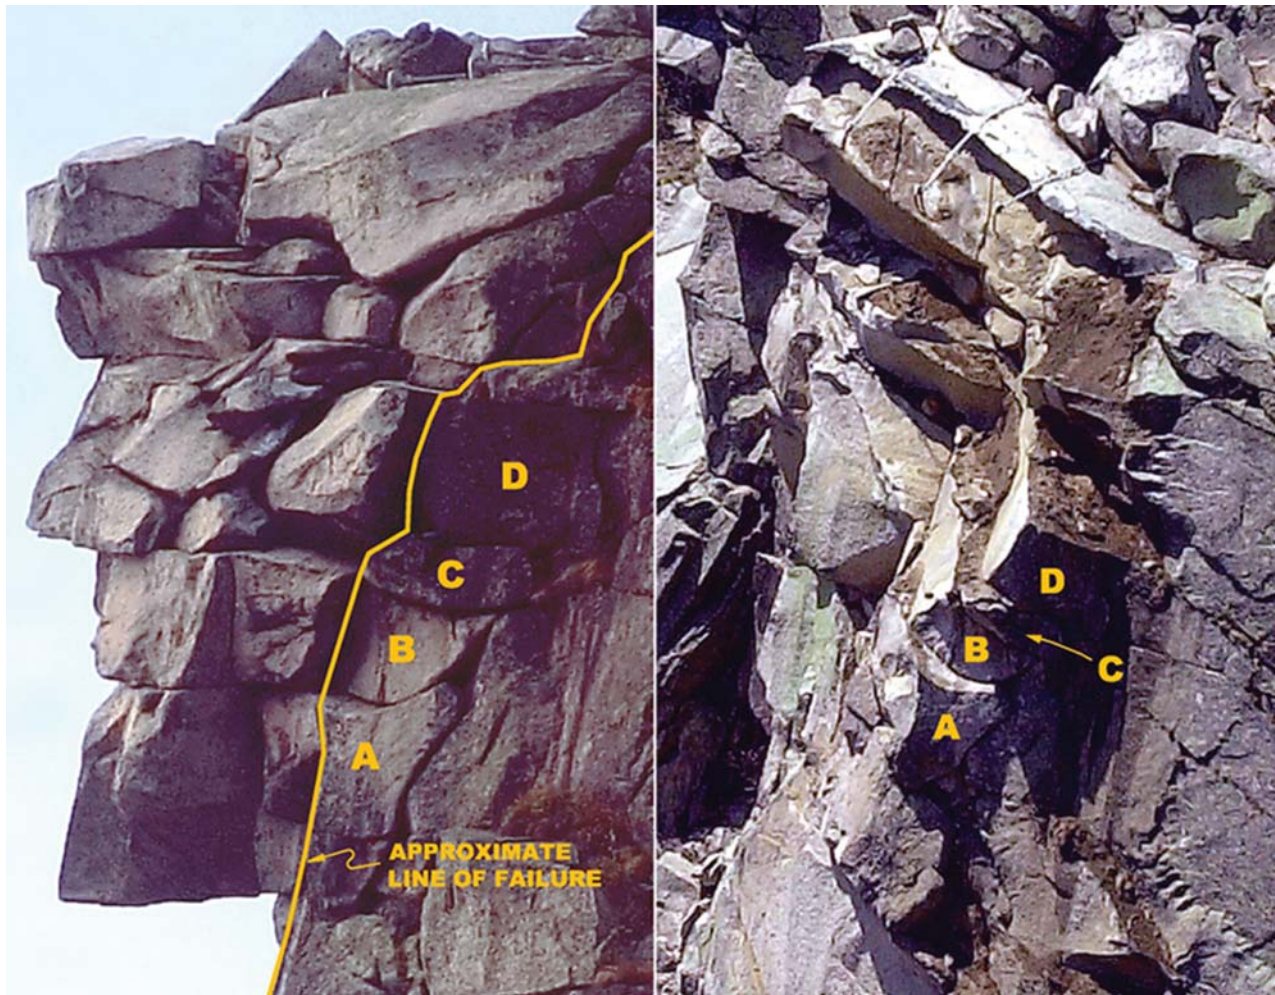
immediately by careful comparison of photographs. The best of these comparisons are presented in Figure 8. These views, before and after collapse, respectively, permit fairly precise determination of what portions of the rock mass collapsed. The blocks marked A through D in both photographs show clearly that the chin and upper lip block combination fell away from the joints separating them from blocks A and B, and the failure line on Figure 8 shows the approximate back line of the blocks and portions of the rest of the blocks that collapsed. All portions of the original composite rock mass collapsed except for the rear portion of the forehead slab.

Figure 8. Profile's rock mass before and after collapse, showing extent of toppling failure. Note forehead turnbuckles in both views (photo at left by J. Cole, Associated Press, 2001; photo at right by Union Leader Corp., 2003).

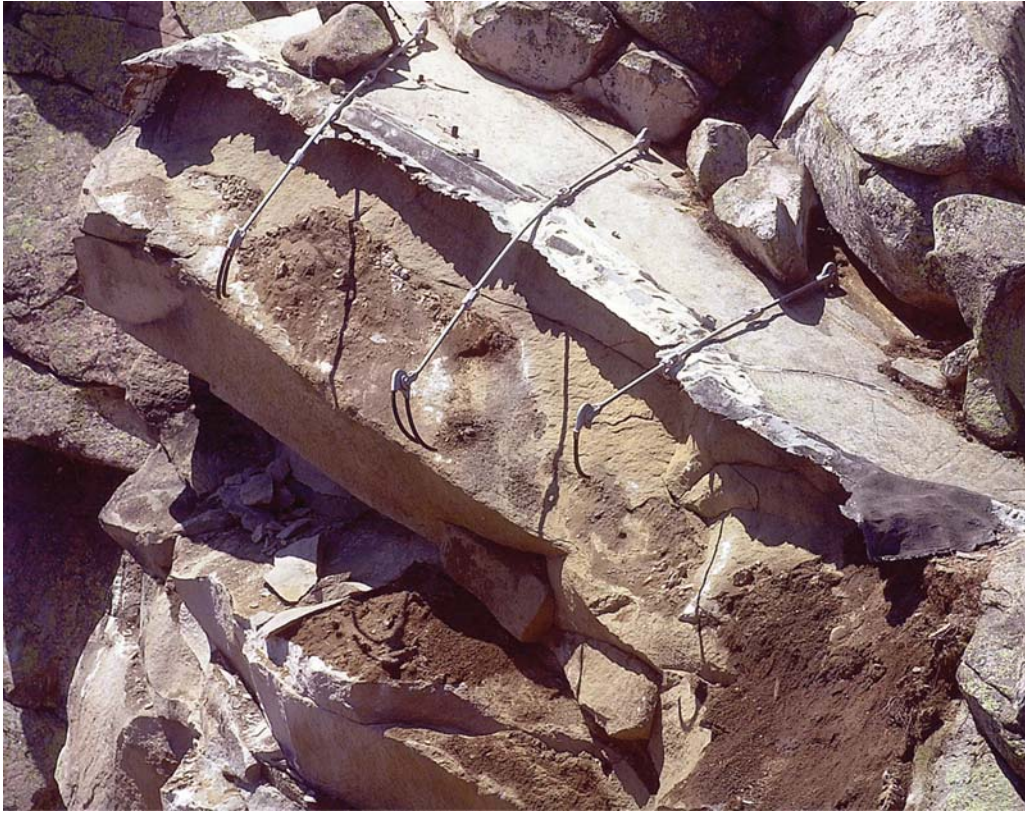
Figure 9 is a view of the top of the residual rock mass showing the un-collapsed rear portion of the forehead slab, into which the large stapled turnbuckles had been installed (Table 2: 1958) along with the residual rock mass below. The backward-curved pattern of deformation of the forward staples that were stripped out of the front portion of the forehead as it moved away indicates the rock mass toppled forward rather than sliding downward. Had sliding occurred, these staples would have been curled in the opposite direction and the line of breakage behind the Profile would not have been left as cleanly defined.

The toppling failure mechanism is also documented by the significant accumulations of weathered granite grus visible on the residual ledges below the residual forehead slab. These volumes of grus, formed by kaolinization weathering of the granite between joint surfaces within the rock mass before its collapse, are surprising given the extensive surficial efforts over the years to prevent such weathering by rain, meltwater, and wind-driven cloud water (Table 2: 1958). Had a sliding failure occurred, these loosely granular accumulations of grus would have been swept away with the collapse.

Figure 9. Close-up, top of the Profile's residual rock mass (photo by Union Leader Corp., 2003).
